Montecito Ponds Report (corrected 6 August 2017)

Purpose: To provide information to residents so that they may better understand the issues related to the ponds in our community development district.

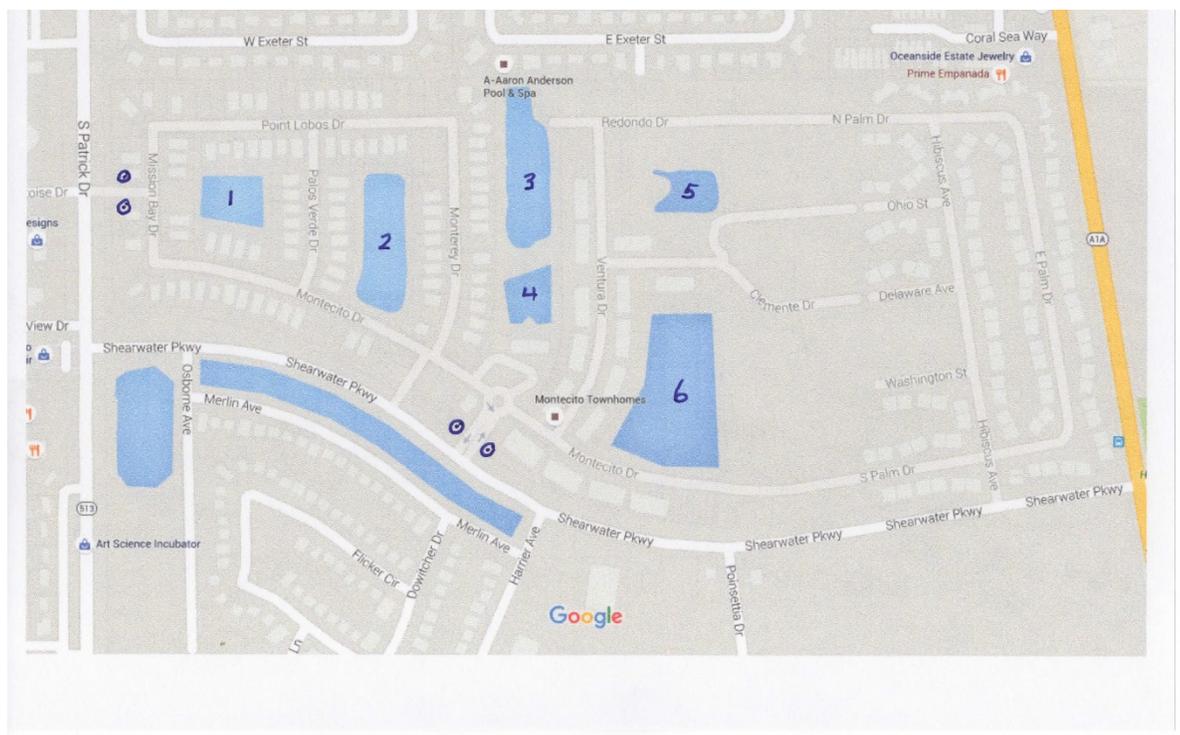
History and description: During the initial development of Montecito, prior to 10 May 2006, six ponds were excavated by the developer for the purposes of providing water for irrigation of the community's landscaping and for their beauty. The location of the ponds is shown in the diagram below

During creation of the ponds, underground equalizer pipes were placed which interconnect them. (These are not shown on the diagram.) The purpose of the equalizer pipes is to keep the water in the ponds at the same level. During the past year (as part of the phase 2C development

of the remaining townhomes' section), pond number 5 was enlarged in an east-ward direction, approximately doubling its size from that shown in the diagram.

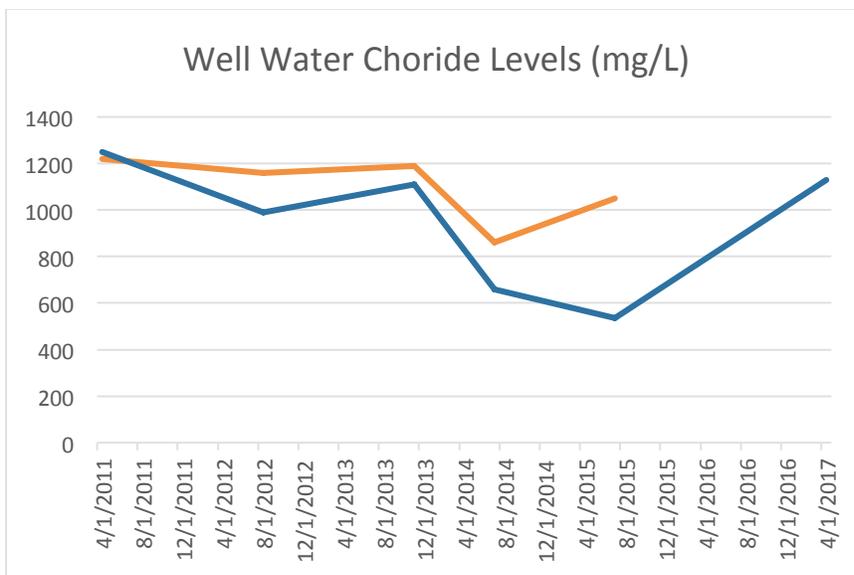
Historically, we have always had chloride in our well and pond water. Shown in the graphs below are the values for well water chloride concentration dating back to 2011.

(Well 2 is the golden graph and well 3 is the blue graph.)
